# MULTI-SITE INSPECTION IDENTIFIES HEIGHT SAFETY SYSTEM FLAWS

*A Gold Coast health operator asked Height Dynamics to independently assess the compliance and condition of height safety installations on its buildings*

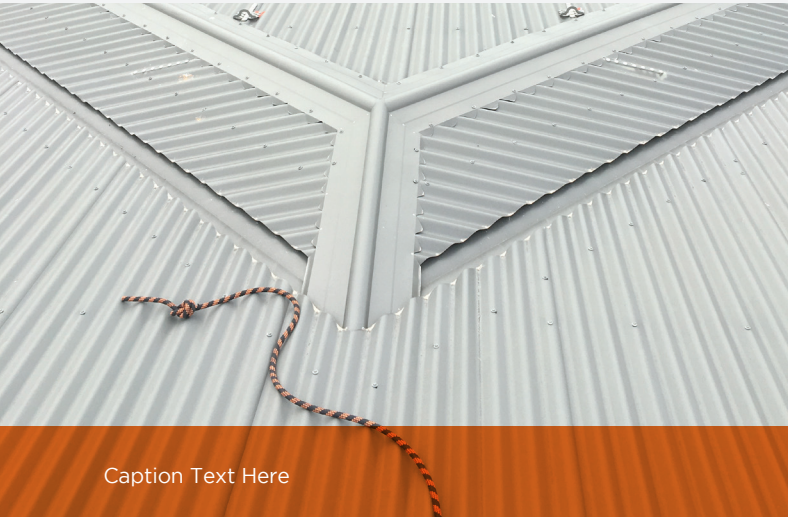
Height Dynamics decommissioned several Safetylink Froglink anchor points because of their positioning on a “short” roof sheet with minimal roof fixing screws into the roof structure. This setup was compromising the anchor point’s ability to perform as intended in the event of a fallen worker. Stitching screws into flashing only above anchor.

We relocated these anchor points to a position that would guarantee proper performance and structure integrity while still allowing safe, roped access to the entire roof area.

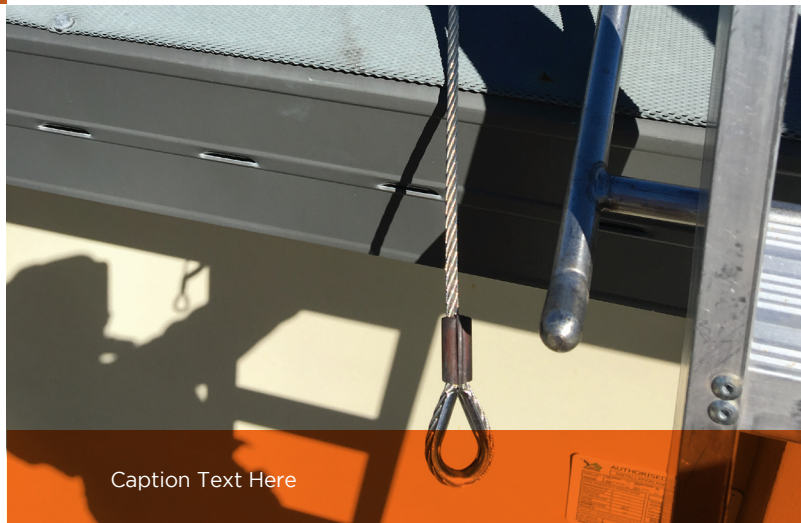
Height Dynamics also decommissioned a complete anchor point roof safety system on a single storey building because of the extended length of the anchor point extension strop at the system access point. The extension strop operator attachment point hung over the gutter line. When used in conjunction with a fall arrest lanyard this increased the fall distance.

If there was a fall, the operator could strike the ground and be seriously injury before the safety system engaged.
